House connection renewed with cable burster X 300 C

House connection renewed

Job site report

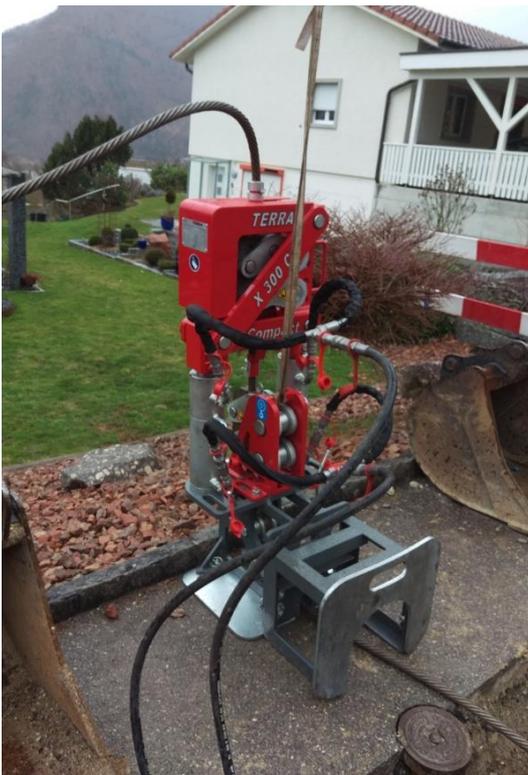
Pic. 1: The pulling cable is pushed through the old pipe. The cable burster is lifted into the pit.

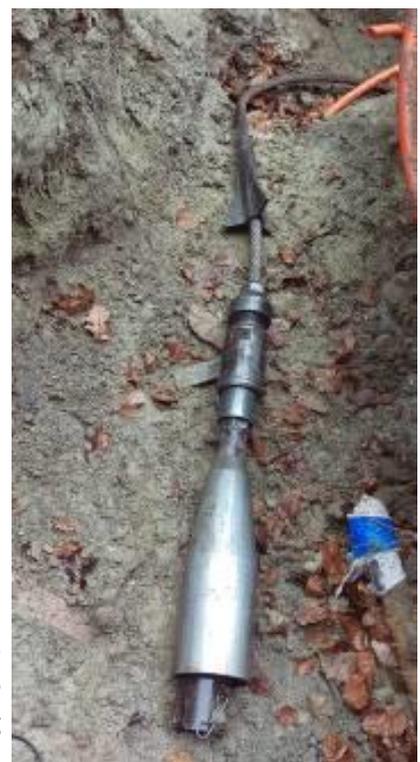
Pic. 2: The 3-wing cutter, the cable coupling and the expander cone are assembled in the bursting

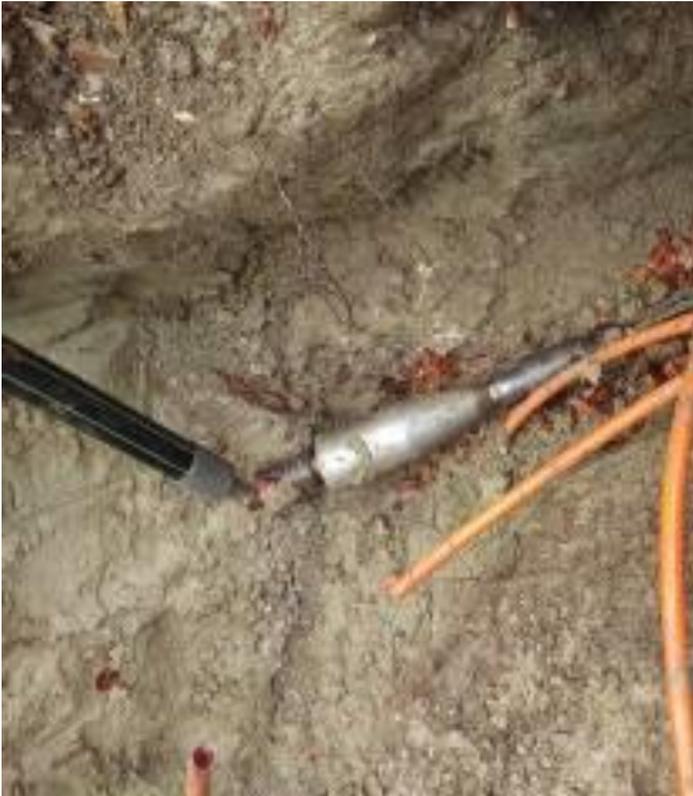
Pic. 3: The PE protection pipe OD 72 mm (2.8") is assembled behind the expander cone in the burst pit.

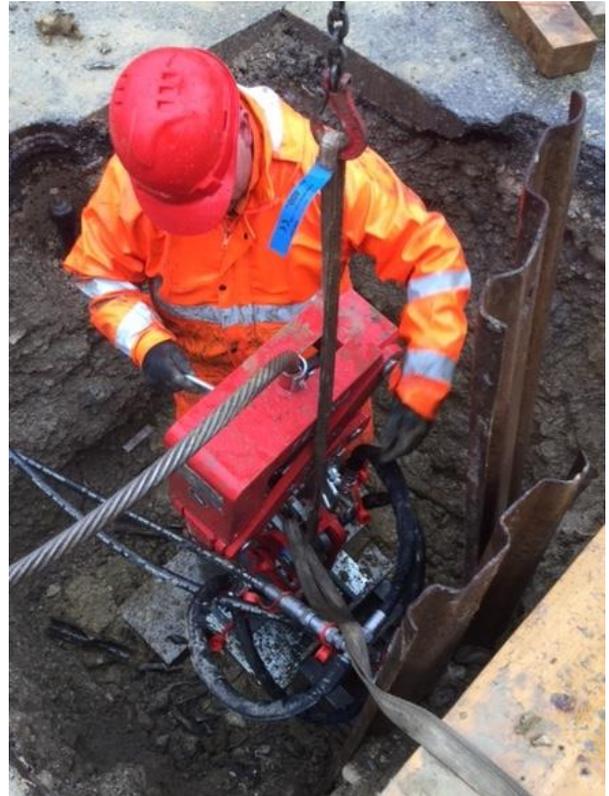
Pic. 4: The cable burster in the pit after the finished pipe bursting procedure.

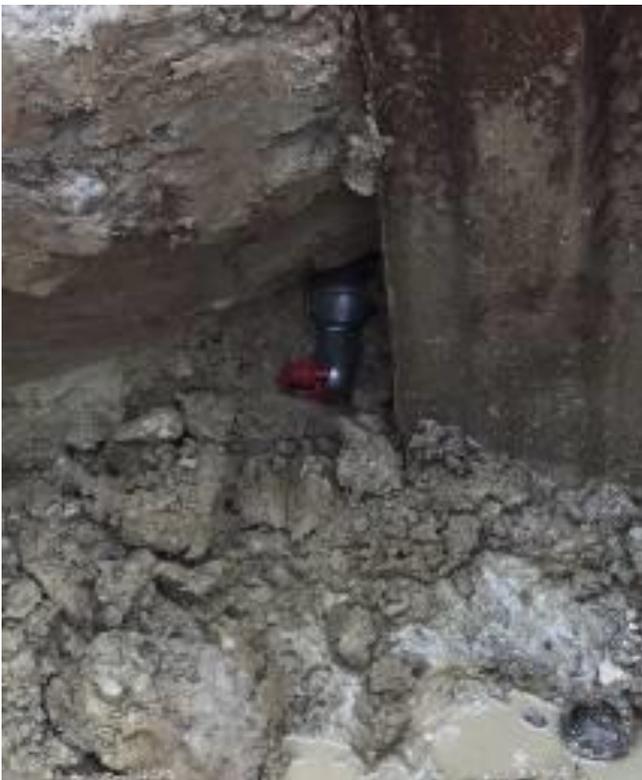
Pic. 5: The protection pipe reaches the machine pit.

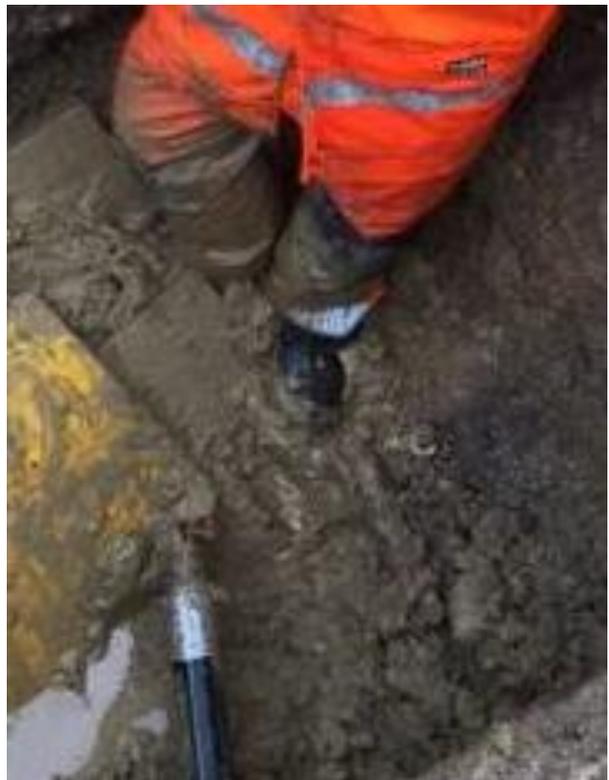
Pic. 6: The protection pipe is pulled into the machine pit. Then the product pipe is pushed into the protection pipe.

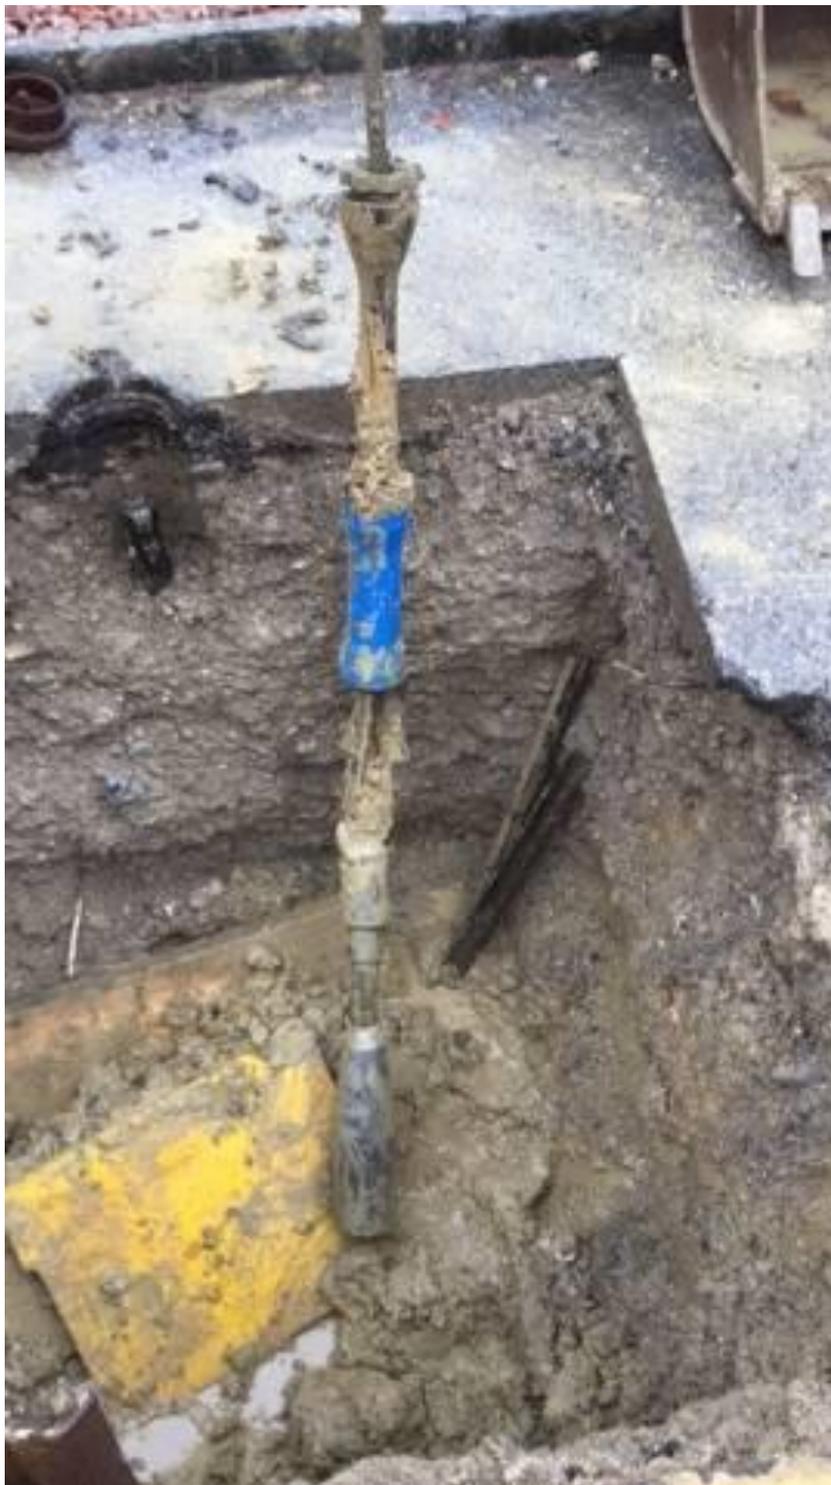
Repair collar

Pic. 7: The repair collar from ductile cast iron could not be cut. It was pushed of the ground.
